# Shattered rim and shelling of high-speed railway wheels in the very-high-cycle fatigue regime under rolling contact loading

Due to the improvement of the wear property, rolling contact fatigue including shattered rim and shelling are the main failure causes of the high-speed railway wheels. In this paper, shattered rim and shelling occurred on the service wheels of the China Railway High-speed (CRH) trains were systematically investigated. The recorded data of the last ten years CRH operation indicated that all shattered rims and shelling were detected with serving  $> 10^6$  km (corresponding to the fatigue life  $10^7$ – $10^9$  cycles) which is very-high-cycle fatigue (VHCF). The crack initiation region of shattered rim located at the depth of 10–25 mm from the tread, while that of shelling located at the depth  $< 10$  mm from the tread. The VHCF features under rolling contact loading were observed on the opening crack surfaces, i.e., similar VHCF features in uniaxial loading including the defect, fish-eye, and crack propagation region and unique VHCF features of the three dimensional crack surface feature, beach bands uniformly distributed in the crack propagation region, a

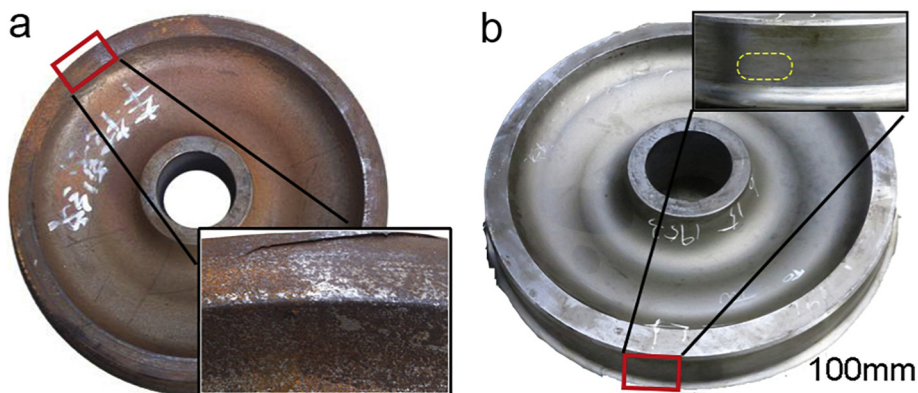
Four railway wheels (two with shattered rims and two with shelling) were removed from the CRH for further investigation. It is worth noting that shelling in this paper refer to the subsurface defect induced failure. Fig. 1 shows two removed shattered rims on CRH rail vehicles. A crack was observed on the rim which has extended to the tread as shown in Fig. 1a, called penetrating shattered rim. No crack was observed on the tread and rim of the wheel as shown in Fig. 1b. However, a crack was detected by ultrasonic detection, which called non-penetrating shattered rim. The non-penetrating shattered rim will extend to the rim with further service. Fig. 2 presents two typical shelling on the CRH wheels that caused the failure of wheels. The ultrasonic detection was applied to detect the crack under the tread. A crack with the area of  $30\text{ mm} \times 30\text{ mm}$  was detected in the wheel (Fig. 2a), and the location is 3 mm depth from the tread. The wheel in Fig. 2b also contained a crack with the area of  $8\text{ mm} \times 20\text{ mm}$ , and the location is about 4 mm depth from the tread surface.

Fig. 1. Photographs taken from CRH wheels showing (a) penetrating, and (b) non-penetrating shattered rims.

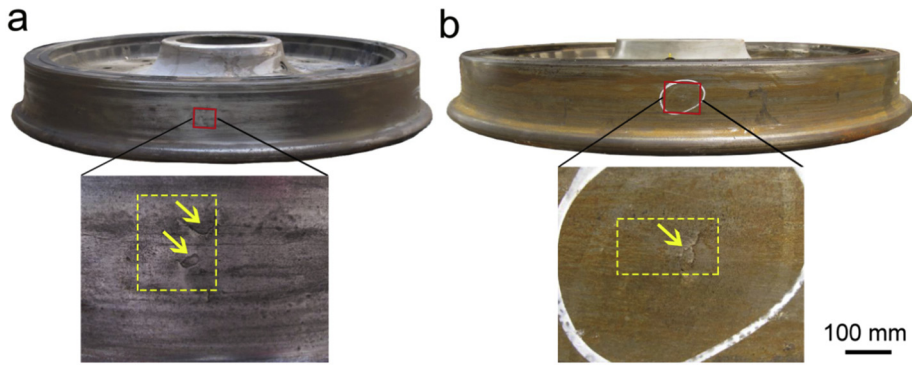
Fig. 2. Photographs taken from CRH wheels showing (a) multipoints, and (b) single point shelling.

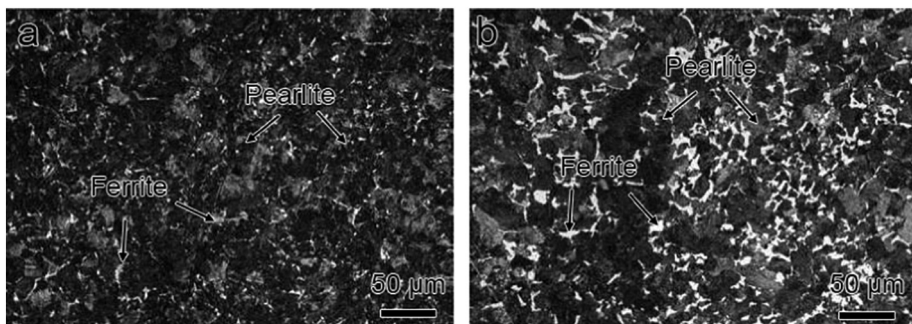
heat-treatment. Due to cooling rates at tread and interior of wheel rim, difference in ferrite fraction was observed as shown in Fig. 3. The microstructure under the tread is abundant pearlite with trace ferrite (Fig. 3a). The microstructure in the interior was found to consist of pearlite and ferrite (Fig. 3b), and the distribution of the ferrite is heterogeneous. Fig. 4 presents the typical inclusions in the wheel steels. The size of the inclusion is about 20 μm. Nonmetallic inclusion is prevalent in the steels. The aluminium acted as deoxidizer during the smelting processing of steels which results in the introduction of aluminium oxide inclusions to steels. In addition, the mechanical properties of the material were measured by tensile testing on an MTS 810 system with cylindrical specimens of 6 mm in diameter and at a strain rate of 10<sup>-4</sup> s<sup>-1</sup>. Five specimens were tested to obtain the yield strength of 673 MPa, the tensile strength of 950 MPa and the uniform elongation of 11.5% for the material.

Fig. 3. Microstructure of the wheels by optical microscopy, (a) surface, and (b) interior.

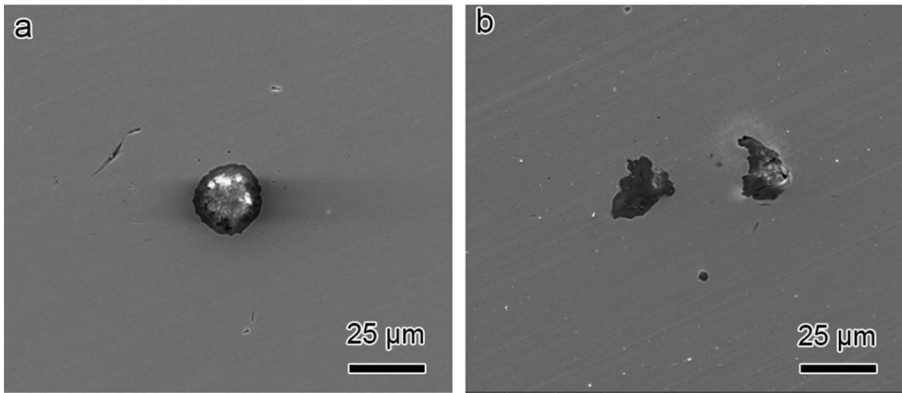
Fig. 4. Inclusions in the steels, (a) Type I, and (b) Type II.

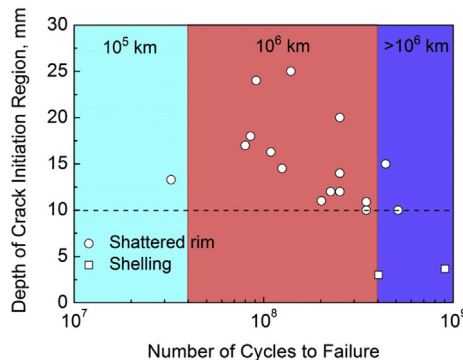
Fig. 6. Depth of crack initiation region versus fatigue life.

shattered rim and shelling. The fatigue life is independent with the depth of the crack initiation region. The depth of the crack initiation region from the tread is in the range of 10–25 mm for all the shattered rims, and that for shelling is < 10 mm. The wheels with shattered rim or shelling were recorded with the service of  $10^5$ – $10^7$  km, and the corresponding fatigue life is within a range of  $10^7$ – $10^9$  cycles. In general, the service stress is below the conventional fatigue limit. Considering the crack initiation site, service stress and fatigue life, the shattered rim and shelling can be regarded as VHCF behavior.

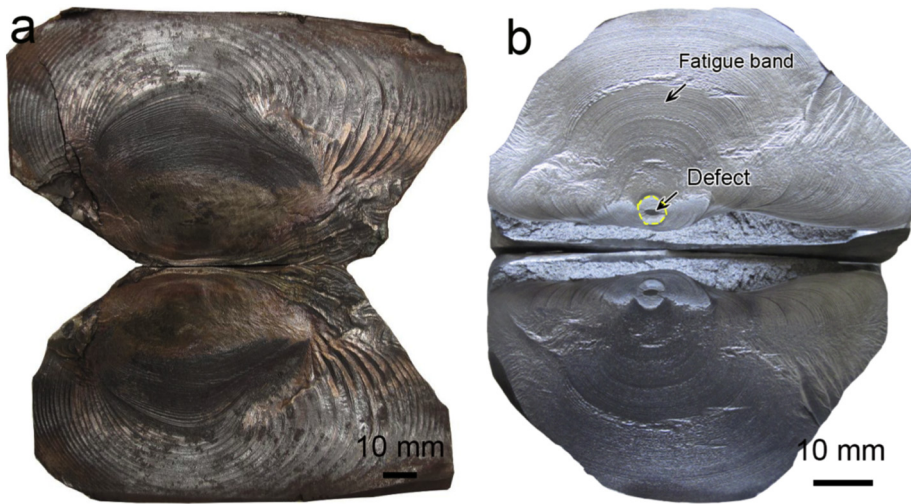
Fig. 7. Shattered rim surfaces, (a) penetrating, and (b) non-penetrating.

Fig. 7 presents the opening crack surfaces of the shattered rims. Fig. 7a is the crack surfaces of the penetrating shattered rim corresponding to the wheel in Fig. 1a. Although the crack surfaces have been contaminated due to oxidation and the crack initiation region is slightly blurred due to the corrosion, it is clear that the crack initiated and fatigue fractured from the interior of the wheel. Fig. 7b is the non-penetrating shattered rim surfaces corresponding to the wheel in Fig. 1b. The crack surface is fresh and clear, which is helpful for the investigation of crack initiation mechanism. The crack initiation region contains a defect surrounded by a flat region marked by a dot line. Abundant beach bands were located in the crack growth region.

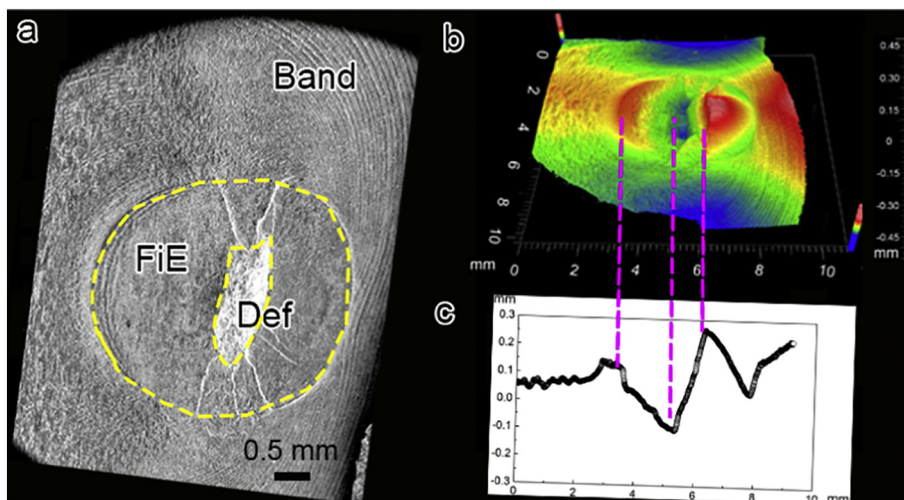
The fracture surface of shattered rims was observed by scanning electron microscope (SEM) and 3D Confocal Microscope Phase Shift MicroXAM. Fig. 8a presents the SEM results, indicating three typical regions with different morphologies, i.e., the defect (Def), fish-eye (FiE), and crack propagation region with beach marks (Band). Fig. 8b and c present the 3D shape of the fracture surface. The defect, the fish-eye, and the crack propagation region are not on the same plane. It can be seen from Fig. 8c that the defect and fish-eye have a height difference of about 0.4 mm. This is different from previously reported fracture surfaces of VHCF

Fig. 8. Fracture surface morphology by SEM and phase shift microXAM-3D, (a) 2D, (b) 3D and (c) fluctuate in the profile.

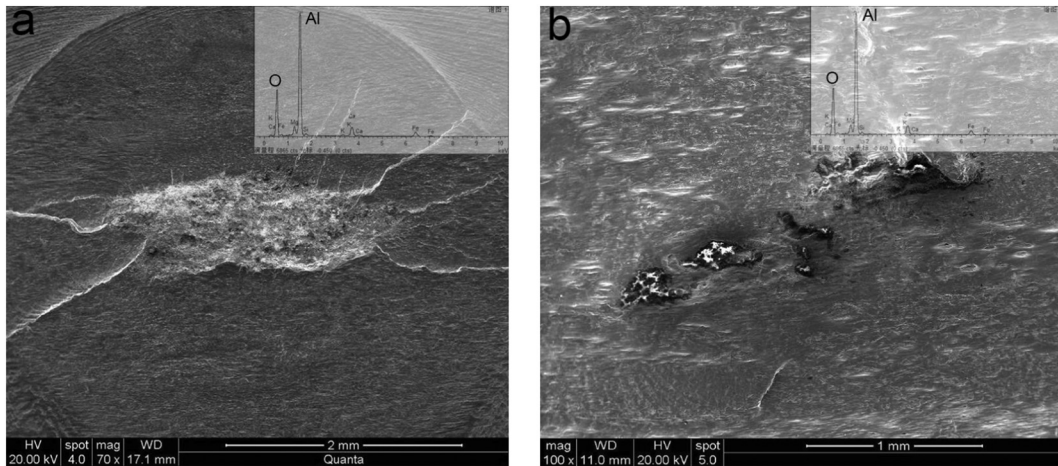
Fig. 9. Defects for the shattered rims, (a) one defect, and (b) defect cluster, Insets showing the EDS results of the defects.

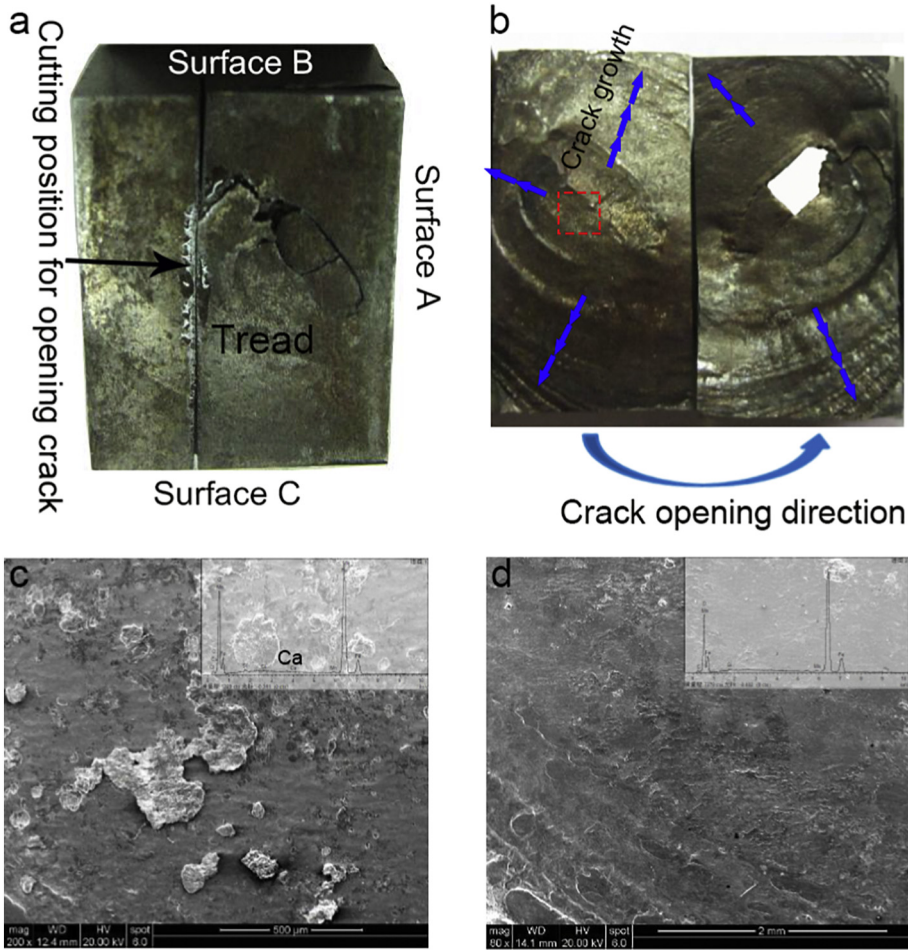
Fig. 10a presents the sample containing the shelling crack cut from the wheel shown in Fig. 2b. Surfaces A, B and C are prepared for crack and microstructure observations. The cutting position on the tread was marked by the arrow for opening the crack. The opening crack surfaces are presented in Fig. 10b. The crack surfaces were somewhat corroded and extruded, but the fatigue fracture features were evident. It is worth noting that part of the crack surface was missing due to wearing. The crack initiation site can be distinguished (Marked by the red box). The morphology is similar with that in Fig. 8, which can be regarded as the same fatigue behavior. Fig. 10c presents the crack initiation site observed by SEM. Defect was found in this region which were confirmed by EDS. Fig. 9d presents the crack propagation region. Beach bands were observed in this region.

**Fig. 10.** Observations of the opening crack surface, (a) sample cut from the wheel, (b) opening crack surface, (c) crack initiation site by SEM, and (d) crack propagate region.

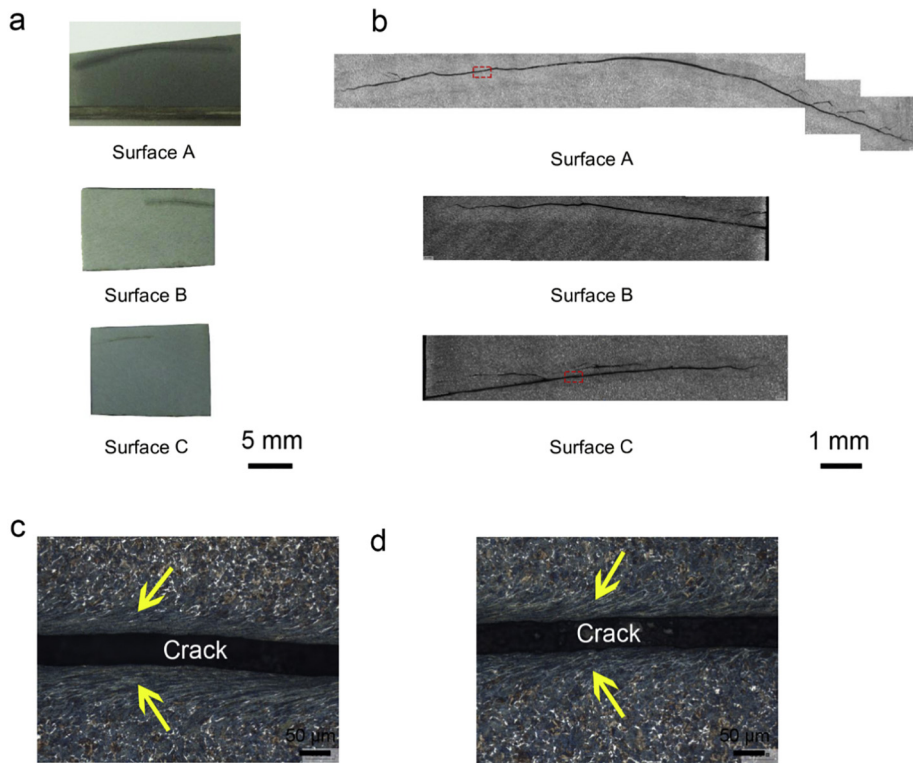
Fig. 11a presents the three surfaces prepared for observations. Surface A contains a 19 mm length crack, and the deepest location of the crack is about 2.3 mm. The crack in Surface B is 7.7 mm in length, and that in Surface C is also 7.7 mm. The deepest locations are 2 mm and 2.3 mm respectively. Fig. 11b presents the morphology of the crack, indicating that the crack growth direction is almost parallel to the tread. Second cracks were observed for all the cases, which is related to the rolling contact loading. Fig. 11c and d present the microstructure around the cracks. A shear plastic deformation microstructure layer with 70  $\mu\text{m}$  thickness (marked by arrows) was observed around the crack, which supported that the crack is driven by shear stress.

Fig. 11. Observations of the cracks and microstructure, (a) metallographic observation surface A, B and C, (b) Cracks in Surface A, B and C, (c) and (d) microstructure around the cracks.

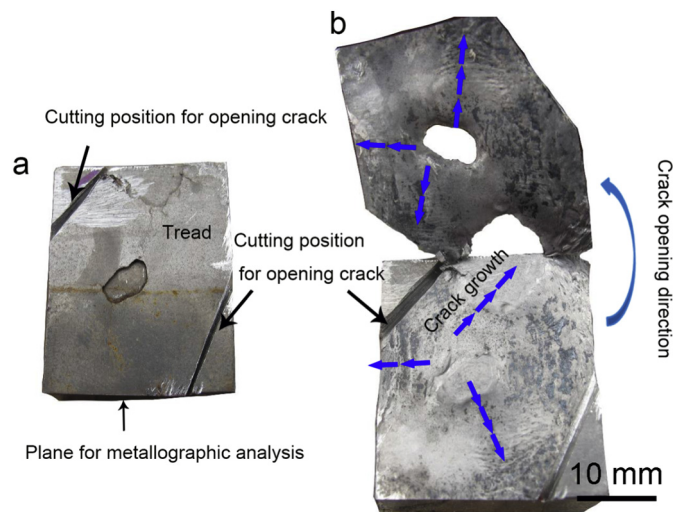
Fig. 12a presents another sample containing the shelling crack cut from the wheel in Fig. 2a. The cutting position on the tread was marked by the arrows for opening the crack. A surface was prepared for crack and microstructure observations which were presented in Fig. 12. The opening crack surfaces are presented in Fig. 12b. It is indicated that fatigue fracture characteristics were presented although the crack surfaces were corroded and extruded. Shelling occurred on the crack surface of tread. Fig. 13a presents the metallographic surface prepared for observations. The service load of the wheels is rolling contact, which causes plastic deformation (marked by arrows) on the tread as shown in Fig. 13b. The grain refinement occurred in the tread, and the grain size increases gradually with an increasing depth. The microstructures around the cracks near tread are presented in Fig. 13c and d, indicating also evident grain refinement (marked by arrows).

Fig. 12. Observations of the opening crack surface, (a) sample cut from the wheel, (b) opening crack surface.

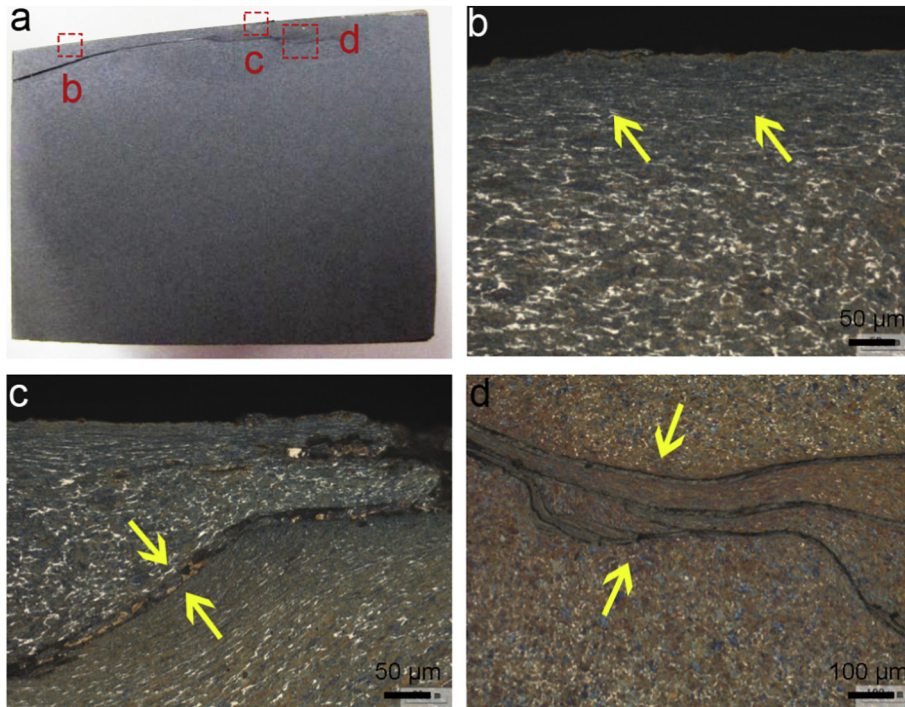
**Fig. 13.** Observations of the cracks and microstructure, (a) metallographic surface, (b) microstructure on the tread, (c) and (d) microstructure around the cracks.

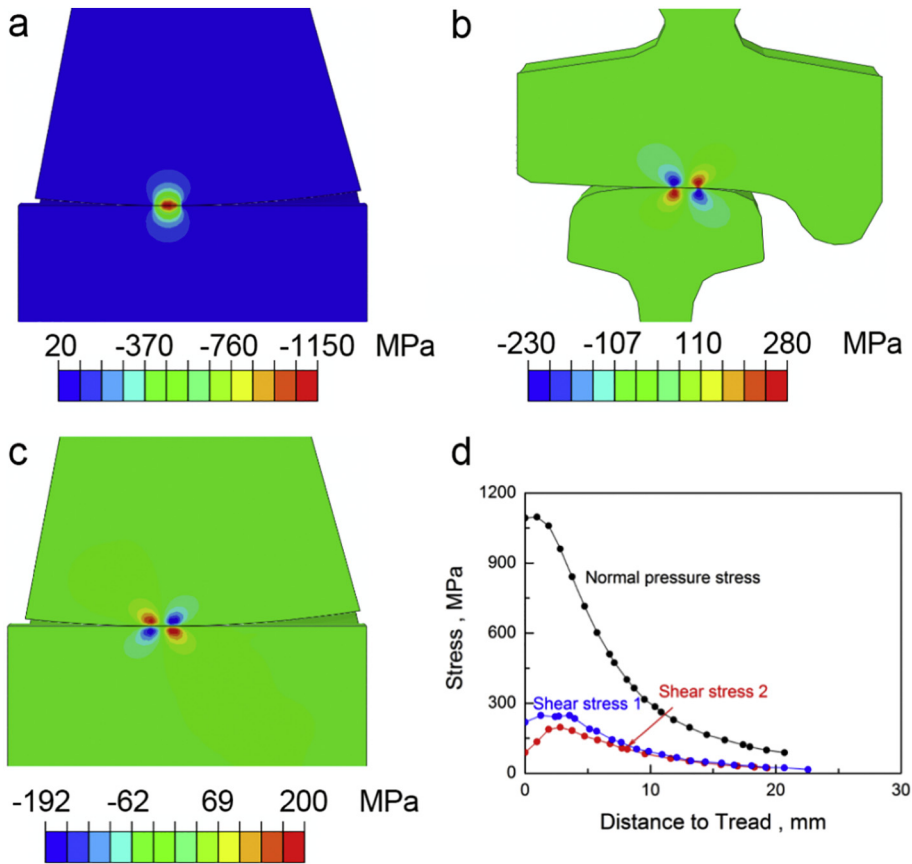
surface. The multiaxial stress consists of a pressure stress in the radial direction (Fig. 14a), a shear stress in axle direction (Fig. 14b) and a shear stress in circumference direction (Fig. 14c). The results in Fig. 14 indicated that only a small region of the contact location bears high stress, the maximum stress located at the depth of about 2 mm while the stress in the other parts of the wheel is almost zero. Fig. 14d presents the stress variation along the radial direction of the wheel. For the case of shelling (subsurface crack initiation) with the depth 0–10 mm, the pressure stress is very high and decreases with the increase of the depth. The existence of the high pressure will cause the severe plastic deformation near the tread (Fig. 10c and 12c) and the press of the crack surfaces (Fig. 9b and 11b). The two shear stress increase first from the tread surface to the 2 mm depth of the wheel, and the maximum shear stress occurs at about 2 mm depth from the tread. These two shear stresses are the driven force of the subsurface crack initiation and propagation. For the case of shattered rim (interior crack initiation) with the depth 10–25 mm, the pressure stress is in the elastic stage, and no evident press between the crack surface was observed (Fig. 6). Meanwhile, the two shear stresses are also in the low level. It is consistent with VHCF features of a relatively low cyclic stress below conventional fatigue limit and beyond  $10^7$  fatigue cycles.

Fig. 14. Stress distribution of wheel/rail contact, (a) pressure stress contour in radial direction, (b) shear stress contour in axle direction, and (c) shear stress in circumference direction, and (d) stress variation along the radial direction of the wheel.

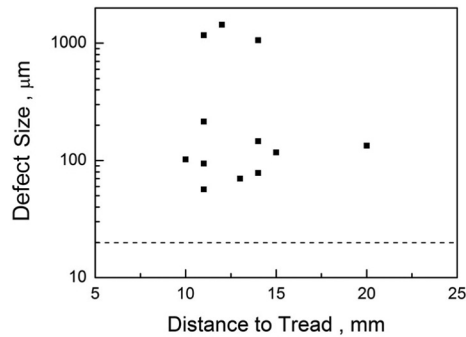
Although the Murakami model is applied to evaluate the VHCF in uniaxial loading, the fatigue strength under rolling contact loading can be regarded as proportional to the hardness and inversely proportional to the defect size. According to Eq. (1), the defect size and hardness distribution were measured. Fig. 15 presents the defect size that induced shattered rim and shelling of the wheels. In general, the size of defects that induced fatigue is larger than the average defect size in the material. In Fig. 15, the minimum size of defect that induced shattered rim and shelling is 56.7 μm, which is almost more than three times of the average defect size (20 μm). The maximum defect size is 1439.4 μm, about 72 times of the average defect size. Therefore, all of the defect sizes that induce crack initiation exceeded the average size. As listed in Eq. (1), the fatigue strength decrease with the increase of the defect size.

Fig. 15. Defect size versus depth from the tread.

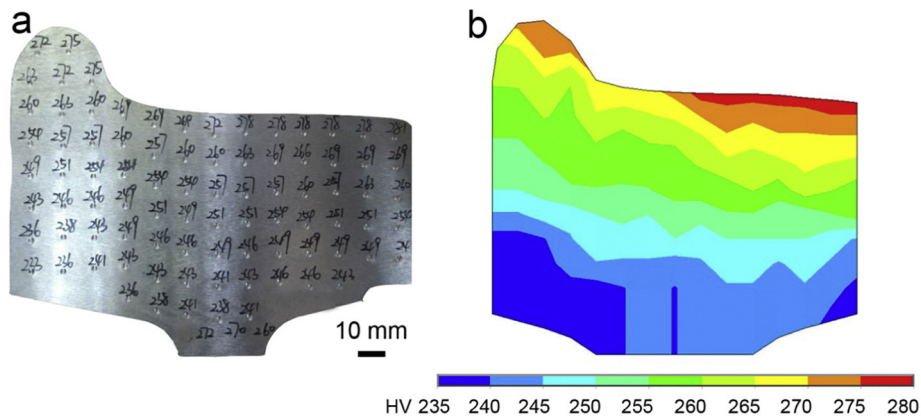
presents the hardness distribution of the wheel profile. Fig. 16a shows the measure points and corresponding values of Brinell hardness. Vickers hardness was used in the prediction of fatigue strength in Eq. (1). Then, Fig. 16b presents the corresponding Vickers hardness distribution, indicating that the hardness value decreases gradually with an increasing depth from the tread. The hardness for the depth of 0–10 mm to the tread is in range of 270–280 Hv, The value of the hardness for the 10–25 mm depth is 260–270 Hv. Although the stress is larger in the surface, the gradient distribution of hardness for hard surface and soft core can suppress the surface crack initiation.

Fig. 16. Hardness distribution of the wheel profile, (a) measure points and corresponding values, and (b) corresponding Vickers hardness contour.

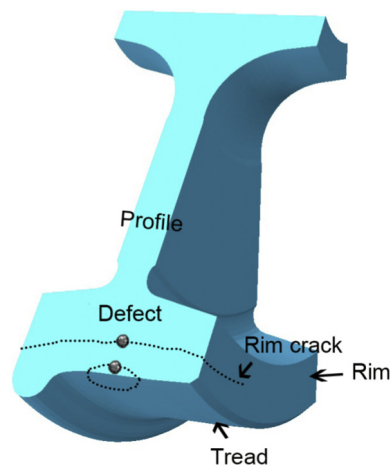
Fig. 17 presents the schematic for the formation mechanism of shattered rim and shelling induced by defects. When the defect locates at the subsurface of the tread with the depth < 10 mm, crack induced by the defect will prefer to propagate to the tread instead of the rim, called shelling. This will cause damage on the tread, and influence the service of the wheel. With turning repair, the wheel can continue the service. When the defect is located at interior of the wheel and is deeper than 10 mm, the crack will propagate to the rim instead of the tread. The shattered rim will lead to the failure of the wheel, even disaster to the train. Models such as “hydrogen assisted crack growth” [27,28], “decohesion of spherical carbide” [29,30], and “formation and debonding of fine granular layer” [19,20] have been proposed for describing the crack initiation mechanism for the VHCF of steels. For the mechanism of “hydrogen assisted crack growth”, it was stated that the existence of locally concentrated hydrogen trapped by a defect induced the discrete crack growth at a very slow rate during crack initiation. The mechanism of “decohesion of spherical carbide” attributes the decohesions of spherical carbides from the matrix to the crack initiation of VHCF. The debondings of the fine granular layer and the matrix are responsible for the early cracks in the model of “formation and debonding of fine granular layer”.

Fig. 17. Schematic of shattered rim and shelling induced by defects.
