# Experimental Study of the Acid Corrosion Effects on an Intumescent Coating for Steel Elements

**ABSTRACT:** Acid corrosion may cause the deterioration of the fire resistance of the intumescent fire retardant coatings. This paper reported the results of an experimental study of degradation in fire protection performance of intumescent coating for steel elements after different times of immersion in the hydrochloric acid solution. The morphology, the equivalent thermal resistance, and the changes of the elements and groups contained on the surface of the coatings were investigated. The corrosion mechanism was as follows: when the coating was immersed in the acid solution, the ammonium polyphosphate (APP), pentaerythritol (PER), and melamine (MEL) underwent the process of acid catalyzed hydrolysis, dissolution, and chemical reaction, which led the change of the content ratio of the compositions and caused the deterioration of the coating fire resistance. A prediction method of the remaining fire resistance property for the acid corrosion coatings was proposed, by comprehensively considering the physical and chemical characteristic changing trends of the corroded coating.

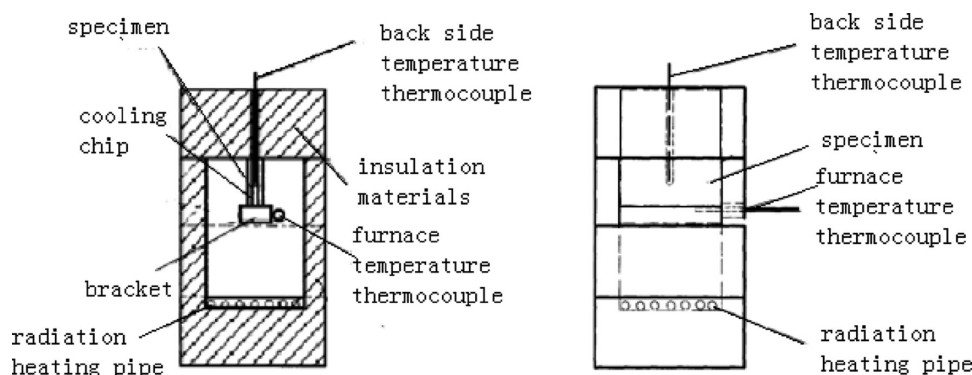
Figure 1. Sections of the fire retardant coating testing furnace.

The fire resistance of the intumescent coatings of the acid treated samples was tested by a small-scale fireproof testing furnace.<sup>14</sup> Figure 1 shows the sections of the furnace used. During testing, the uncoated sides of two specimens were attached at the lower end of the respective sides of a cooling chip, which was made of steel or heat-resistant alloy. Wire was used to combine the cooling chip and the two samples covering the sides of the cooling chip together. The cooling chip and the two samples were placed onto the bracket in the furnace vertically. One thermocouple was placed in the groove of the cooling chip to measure the back-side temperature of the specimens, and another thermocouple was placed in the furnace to monitor the temperature of the furnace. The time–temperature curve in the furnace is in accordance with the ISO 834 standard curve. The time when the back side temperature of the samples reaches 538 °C is defined as the fire-resistance time. Figure 2 shows the time–temperature curve comparison between the furnace results and the ISO 834 standard.

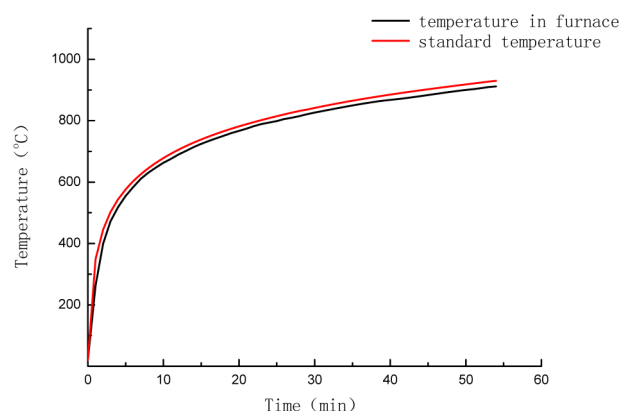
Figure 2. Time–temperature comparison diagram between the furnace and the ISO 834 standard.

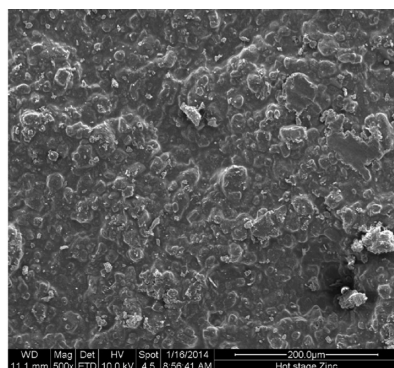
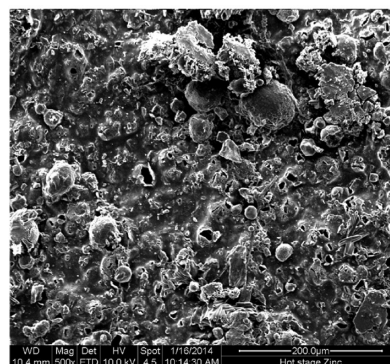
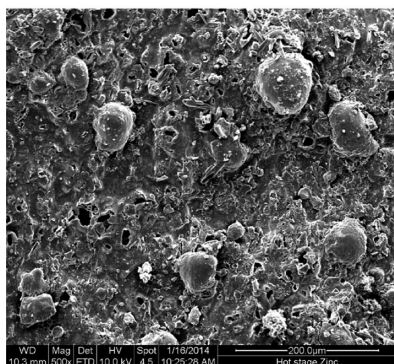
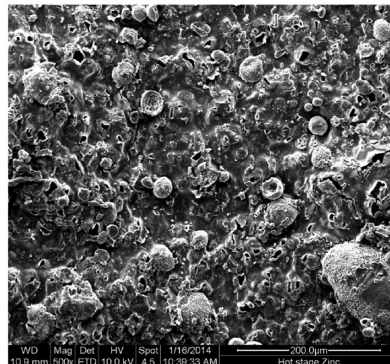
a. Untreated coating surface

b. Coating surface after 8h corrosion

c. Coating surface after 16h corrosion

d. Coating surface after 24h corrosion

**Figure 3.** Surface morphology after different times of corrosion.

To investigate the changes of the surface morphology, the coating surfaces after different acid treatment times were observed using the SEM. Figure 3 shows the surface morphology at a magnification of 500X. The data shown in Figure 3 indicate that the surface of the untreated coating is

relatively smoother compared to the acid treated surfaces. The base resin covered and bonded the surface of the pigments and fillers continuously in the untreated coating. However, the corroded specimen surface was no longer flat, and some particles appeared. After 24 h of corrosion, the particles became smaller and were fewer in number. In addition, some cracks and broken holes could be observed in the corroded samples surface.

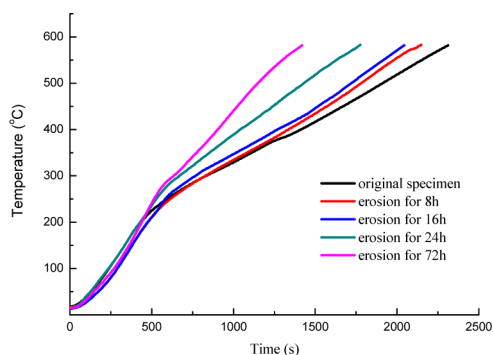
Figure 4. Back side temperature of specimens vs time.

**3.2. The Fire Resistance of the Coating after Corrosion.** *3.2.1. The Fire Resistance Time and the Thickness of the Char Layer.* When the specimens met the prescribed corrosion time, they were moved from the hydrochloric acid solution and then dried under laboratory conditions. Before conducting the fire resistance test, the mixture layer of resin and paraffin was removed. Figure 4 shows the back side temperature of the samples with testing time. For different corrosion time samples, the trends of the temperature rising was found to be similar in the early 400 s, but the behaviors became quite different in the later stage.

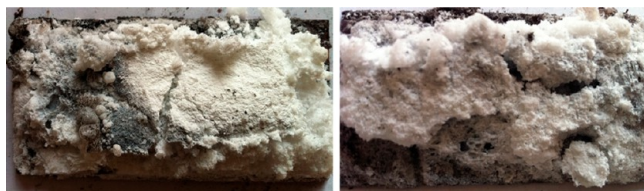
a. The surface of the char layer b. The internal part of the char layer

Figure 6. Char layer of the 16 h corrosion sample.

Figure 6a shows the surface of the char layer of the sample exposed to 16 h of acid corrosion. The surface appears similar to the char layer of the sample exposed to 8 h of acid corrosion. A hard shell also appeared, but the roughness was less than that in the 8 h acid corrosion case, and there were cracks in the surface shell. After removing the hard shell, large cracks and holes could be observed in the internal char layer, as shown in Figure 6b. Similar to the char layers of the samples under acid corrosion for 8 and 16 h, there was hard shell on the char layer surface of the sample under acid corrosion for 24 h. The shell

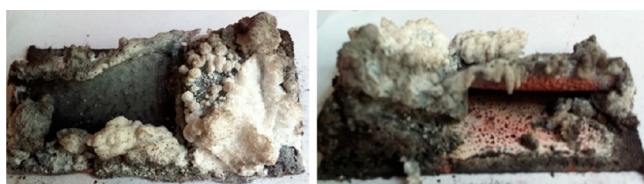
a. The surface of the char layer b. The side view of the char

Figure 8. Char layer of the 72 h corrosion sample.

under acid corrosion for 72 h. Figure 8a shows that the corrosion part did not expand at all, the surface was smooth, the color of the char layer was dark gray, and no obvious expansion char bubble was found. From the side view, the shell was curling and peeled from the substrate, as shown in Figure 8b.

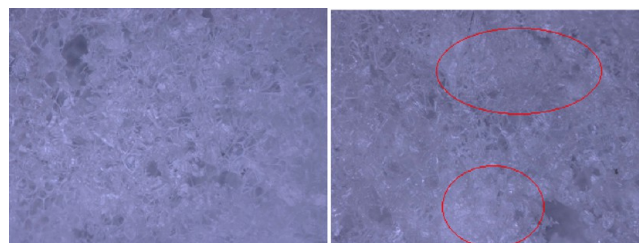
a. The char of the original sample b. The char of the sample for 8h corrosion

c. The char of the sample for 16 h corrosion

Figure 9. Longitudinal section morphology of the char.

To understand the details of the char layer, the morphology of the longitudinal section of the char was observed using stereo microscope at 100× magnification. Figure 9a–c is the char section of the original sample, the corroded sample after 8 h of corrosion, and the corroded sample after 16 h of corrosion, respectively. As shown in the figure, the char of the untreated coating appeared spongy and fluffy, the reinforced fibers of the coating were uniformly distributed in the char layer, and the pores were small and relatively consistent in size. Some “cement” parts (the regions in the red circles of Figure 9b) were formed in the char layer of the sample after 8 h of acid corrosion. The char was not as fluffy as the original one, and the reinforced fiber and the char were bonded together in the “cement” part and could not be distinguished clearly. The pores in the char were large and of nonuniform size. Much more “cement” parts were formed in the char of the 16 h corrosion sample, and only in the vicinity of the pores can the reinforced fiber be identified. The pores in the char became obviously large and small.

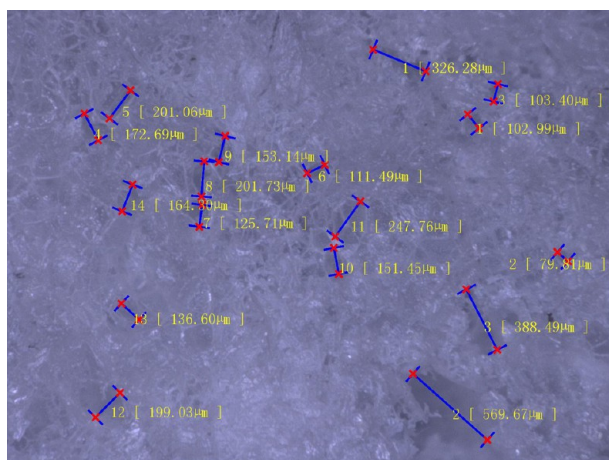
Figure 10. Pore measurement figure of the 8 h corrosion sample.

Using the VHX-100 communication software, the magnitude of the pores in the char were measured and calculated. During the measurement, the pores with clear boundaries were selected. In the visual range, the measured pores were numerous and distributed uniformly. For the irregularly shaped pores, the longest distance between two points at the edge of the pore was the pore size. Figure 10 shows the pore

measurement results of the 8 h corrosion sample. Table 3 presents the measured and calculated data regarding the pore size of the samples of different corrosion periods. Because the char layer of the 24 h corrosion sample was too loose and thin for the observation and the 72 h corrosion sample was not expanded, the two samples were not considered in this test. As seen in Table 3, with the increasing time of corrosion, the size of the char became larger. In addition, the magnitudes of the pore sizes were more dispersed and uneven, resulting in an increase in the pore range, variance, and standard deviation.

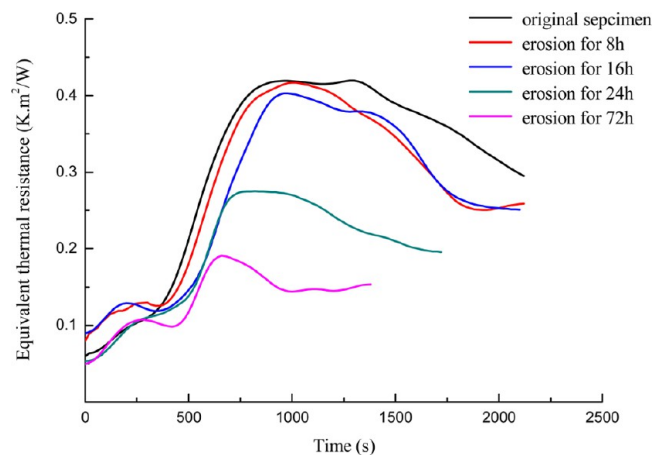
Figure 11. Equivalent thermal resistance vs time of the samples for different corrosion times.

samples for different corrosion times with the heating time. As shown in Figure 11, with the acid corrosion time extended, the equivalent thermal resistance of the coating exhibits an overall trend of decreasing. In the initial 400 s, the equivalent thermal resistance of the 8 and 16 h corrosion samples is slightly higher than that of the others. During this test time period, the back temperature of the samples was below 200 °C. The residual moisture in the coating may be the cause of the higher thermal resistance of the 8 and 16 h corrosion specimens. However, because the thermal resistance during this period is relatively small, and the duration is short, the effect of the thermal resistance difference for the back side temperature of the sample is not significant (see Figure 4). For the heating from 700 s to the end of the test, the equivalent thermal resistances of the samples of different corrosion times exhibit a remarkable

difference. For example, the equivalent thermal resistances of the untreated sample and the 72 h corrosion sample are 0.364 and 0.189  $\text{K}\cdot\text{m}^2/\text{W}$ , respectively; i.e., the former is 1.93 times the latter. At 960 s, the equivalent thermal resistances of the untreated sample and the 72 h corrosion sample are 0.419 and 0.146  $\text{K}\cdot\text{m}^2/\text{W}$ , respectively; the former is 2.87 times of the latter. Regarding the significant differences of the samples over a long time, the insulation effects of the different samples are remarkably diverse, and the resistance times of the samples are distinct from each other.

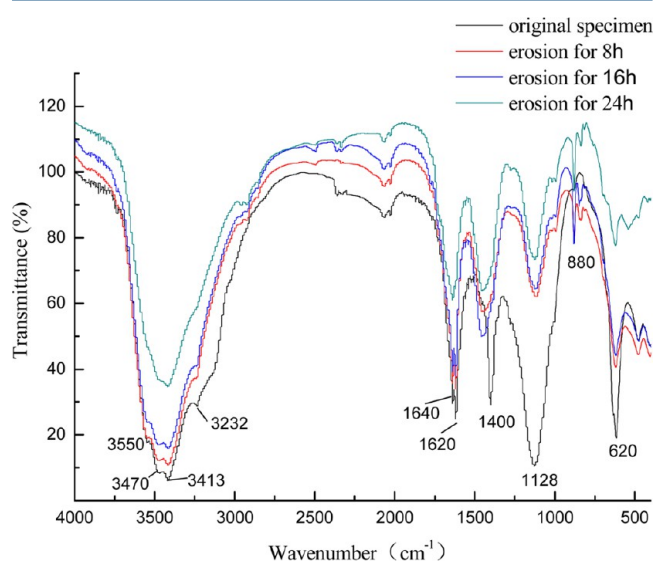
Figure 12. FTIR spectrum of the samples for different corrosion times.

As shown in Figure 12, the groups of the components contained in the different corrosion time samples are similar, but there are slight differences in the contents. The trough at  $3550\text{ cm}^{-1}$  indicates the stretching vibration of the O–H contained in PER; the troughs at  $3470$  and  $3414\text{ cm}^{-1}$  indicate the stretching vibration of the  $\text{NH}_2$  contained in MEL; the trough at  $3232\text{ cm}^{-1}$  also indicates the stretching vibration of the O–H; the trough at  $1640\text{ cm}^{-1}$  indicates the stretching vibration of the C=O contained in the base resin of the coating; the trough at  $1620\text{ cm}^{-1}$  indicates the deformation vibration of the  $\text{NH}_2$ ; the trough at  $1400\text{ cm}^{-1}$  indicates the twisting vibration of the C–H bonds in  $\text{CH}_2$  contained in the base resin of the coating and PER; the trough at  $1128\text{ cm}^{-1}$  indicates the stretching vibration of the  $\text{PO}_4$  and C–O in the alcohol contained in APP and PER, respectively; the trough at  $620\text{ cm}^{-1}$  indicates the out-of-plane bending vibration of the

Analyzing the troughs in the figure, the troughs at  $3550$  and  $3232\text{ cm}^{-1}$  are observed to weaken and eventually disappear with the corrosion time increasing. These results indicate that the PER particles contained in the coating were dissolved in the hydrochloric acid solution during the corrosion process and that the contents in the coating were decreasing. When the corrosion time is relatively short, because of the diffusion of the inertial PER to the surface, the reduction of the groups is not obvious. When the corrosion time reached 24 h, these two troughs disappeared, which demonstrates that the content of the PER decreased significantly; in addition, the weakening of the troughs at wave numbers of  $1128$  and  $620\text{ cm}^{-1}$  also proves this phenomenon. The troughs at  $3470$ ,  $3414$ , and  $1620\text{ cm}^{-1}$ , which are related to MEL, have similar trends to those of PER. That is, for the short duration corrosion samples, the content of the MEL is slightly affected, but for the long duration corrosion samples, the MEL content significantly decreases. In addition, the ammeline, ammeline, and cyanuric acids produced in the action of MEL and hydrochloric acid exhibit absorption peaks at the wavenumbers of  $3470$ ,  $3414$ , and  $1620\text{ cm}^{-1}$ , which also exhibit only slight changes of the troughs for the short time corrosion samples. Considering the troughs in the vicinity of  $1400\text{ cm}^{-1}$ , compared with the untreated coating, the troughs of the corrosion samples become weaker and shifted to the higher wavenumbers. The reason for this phenomenon is that the polarity of the C–H contained in the PER, which is adjacent to the OH, is stronger than the C–H contained in the base resin. Thus, when the content of the PER decreased, the troughs not only become weak but also shift to the higher wavenumber for the reduced polarity of the C–H. The APP hydrolyzes in water, and the presence of the acid can accelerate this process. The troughs at  $885\text{ cm}^{-1}$  appear in the corroded samples, indicating that the pyrophosphate was generated during the hydrolysis of APP. In addition, the content of the pyrophosphate increases with the prolonging of the corrosion time. At the same time, the weakening of the absorption peak at  $1128\text{ cm}^{-1}$  also indicates the hydrolysis of the APP.
