Investigation on the fracture mechanism of homogenized micro-crack crushing technology for portland cement concrete pavement rehabilitation

Cite as: AIP Advances 9, 075113 (2019); <https://doi.org/10.1063/1.5111055>

Wenjie Li,¹ Qunlei Zhang,¹ Zihan Zhi,¹ Chun Feng,² Yingchun Cai,¹ and Jinchao Yue^{1,a)}

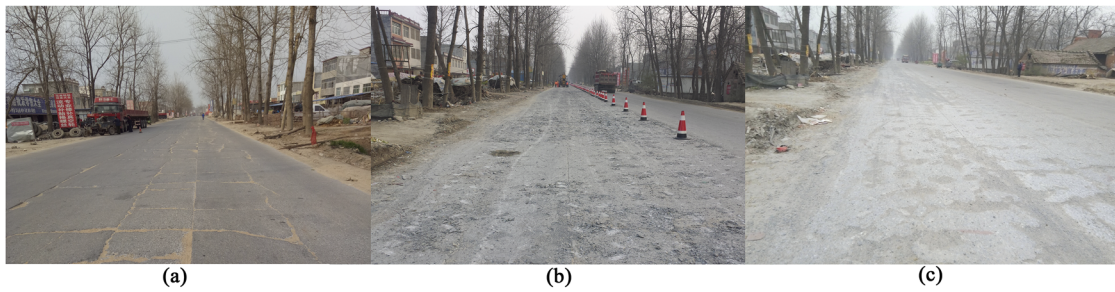
FIG. 15. Cement concrete pavement before and after crushing. (a) Pavement before crushing. (b) Pavement after crushing. (c) After debris cleaning.

along the center. The cement concrete pavement before and after crushing is shown in Fig. 15. After the concrete pavement had been crushed, there was some debris on the surface of the pavement. Once the debris had been cleaned, micro-cracks appeared on the

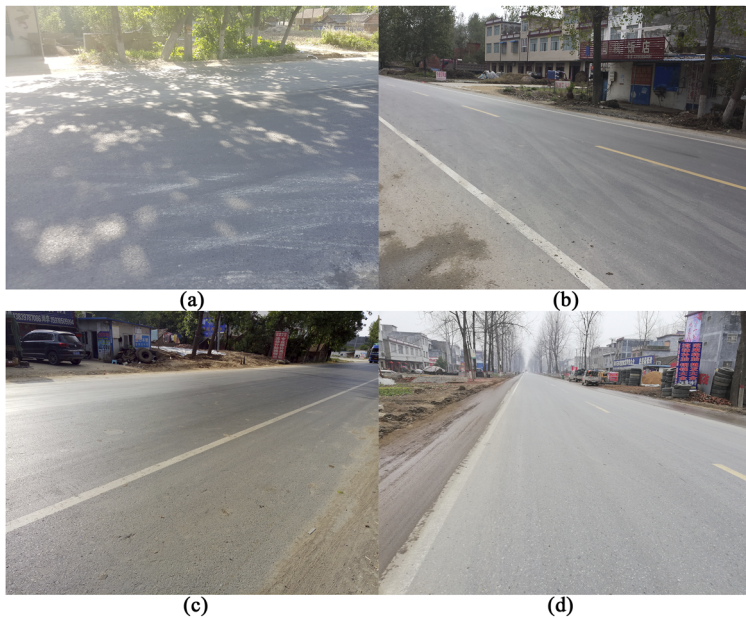
FIG. 20. Pavement conditions after the laying of hot-mix asphalt concrete overlay. (a) After one month. (b) After six months. (c) After one year. (d) Almost two years.

The hot-mix asphalt concrete was directly overlaid after homogenized micro-crack crushing, with a 40 mm AC-16 lower layer and 40 mm AC-13 upper layer. Figure 20 shows the pavement conditions after one month, six months, one year, and almost two years. After almost two years, the International Roughness Index

(IRI), deflection, and texture depth of the hot-mix asphalt concrete overlay were tested in accordance with the requirements of the Inspection and Evaluation Quality Standards for Highway Engineering.³² The results are presented in Table VI. After almost two years of service, the pavement exhibits no obvious distress and its condition is good.
