Very-high-cycle fatigue induced growth and amorphization of Si particles in additively manufactured AlSi10Mg alloy: Dependence of applied stress ratio

Jianghua Li^a, Jingyu Sun^a, Yajing Li^b, Guian Qian^{a,*}, Zhiyang Wang^{c,*}

^a State Key Laboratory of Nonlinear Mechanics (LNM), Institute of Mechanics, Chinese Academy of Sciences, Beijing 100190, China

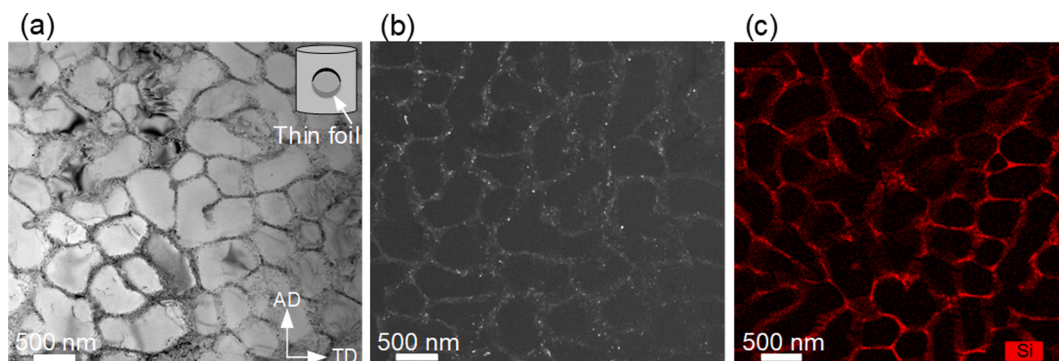
Fig. 2. (a) Bright-field and (b) dark-field TEM images and (c) Si elemental distribution map of the as-built specimen.

Fig. 2(a-c) further shows the TEM observation of cellular structures in the as-built material. The dark-field TEM image (Fig. 2b) indicates that the as-built material is characterized by a cellular microstructure with the precipitates randomly distributed along the cellular network boundaries. The elemental mapping of Si (Fig. 2c) confirms that the as-built cellular microstructure consists of the Si-rich precipitates at the boundaries, consistent with the near-eutectic microstructural nature of studied AlSi10Mg alloy. XRD results indicate that the as-built material consists of Al and Si phases (see the Supplementary Fig. S1).

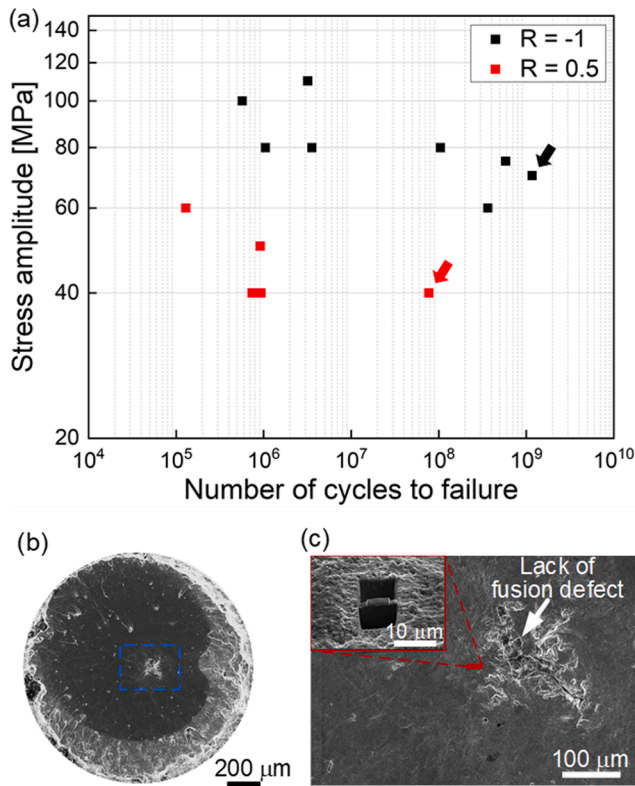
Fig. 3. (a) *S-N* data of fatigue tests with stress ratios $R = -1$ and 0.5, (b) fracture morphologies of a representative specimen after 1.17×10^9 fatigue cycles at $S = 70$ MPa. (c) A closed-view of the crack initiation area in (b).

The *S-N* data (Fig. 3a) shows that the fatigue life of the as-built alloy increases as the applied stress amplitude decreases for both $R = -1$ and

0.5. Based on the fatigue tests in the present condition, under $R = -1$, the VHCF of the as-built material which shows the fatigue life beyond 10^7 cycles normally occurs under an applied stress amplitude below 80 MPa. At higher stress levels (80–110 MPa), the high-cycle fatigue with the fatigue life less than 10^7 cycles occurs. As the stress ratio increases, the fatigue resistance decreases significantly from 80 MPa to 40 MPa at a fatigue life-time of $N_f = 10^8$ cycles.

The fatigue fractographic observations demonstrate that the fatigue cracking of the investigated specimens initiated at the lack of fusion defects. We presented the representative microstructural results from the specimens after 1.17×10^9 fatigue cycles under $R = -1$ and the 7.7×10^7 cycles under $R = 0.5$ in the following, corresponding to the fatigue condition indicated by the black and red arrows in Fig. 3a. Additional fractographic observations of other fatigue test conditions can be found in the Supplementary Fig. S2-4. As represented by the fractographic observations in Fig. 3b, the cracks were mainly initiated inside the specimen under the present VHCF conditions. The characteristic “fish-eye” morphology indicative of the crack initiation and propagation processes was observed on the fracture surface (Fig. 3b). Note that a close inspection of the “fish-eye” region confirms that the presence of the lack of fusion defect in the LPBF specimens promoted the initiation of VHCF cracking (Fig. 3c), which is consistent with previous studies on fatigue of LPBF alloys [28]. This finding implies the significance of eliminating manufacturing defects in the materials for improving their fatigue performance.

The microstructure of fatigued specimens was further characterized by TEM. We focused on two fatigue test conditions of the 1.17×10^9 fatigue cycling under $R = -1$ and the 7.7×10^7 cycles under $R = 0.5$, as marked in the *S-N* data (Fig. 3a) with black and red arrows, respectively. Fig. 3c presents a typical example of the fatigue fracture surface morphology under $R = -1$. The lifting-out position of thin-foil FIB specimens for further TEM and TKD observations is close to crack source, as shown in Fig. 3c.

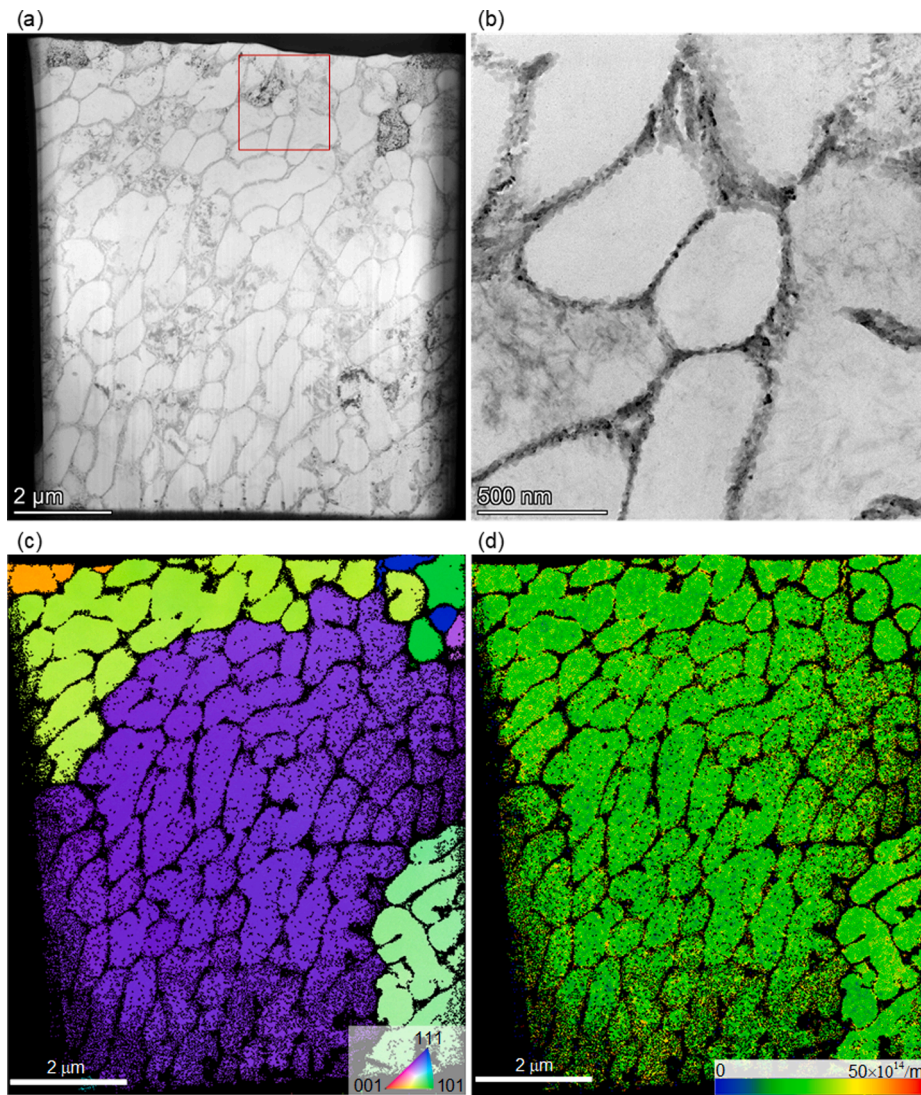
Fig. 4. (a) Bright-field TEM image for fatigued specimen with $R = 0.5$, (b) a closed-view of the box area in (a), (c) TKD-based orientation map corresponding to (a), (d) GND distribution in the same region of (c).

For VHCF specimen with $R = 0.5$, the bright-field TEM image (Fig. 4a) reveals similar microstructures to the as-built material (Fig. 2a), i.e. the fatigued microstructure in this condition remains to exhibit the cellular structures with the precipitates distributed along the cellular network boundaries. Further, a closed-view of the box area in Fig. 4a was performed. The obtained result in Fig. 4b shows that the size of the precipitates on the cellular network boundaries appears to be similar to that in the as-built material. The corresponding TKD-based orientation map of the same region as in Fig. 4a is shown in Fig. 4c. The results indicate that there is no significant misorientation development. No obvious plastic deformation occurred near the fracture surface, and the misorientation within the grains is relatively uniform. The density of geometrically necessary dislocations (GNDs) was estimated based on the lattice curvature following the approach described in Ref. [29]. Fig. 4d presents the determined GNDs density distribution corresponding to Fig. 4c. No appreciable accumulation of GNDs was observed within the Al grains in this condition.

Interestingly, the size of the Si precipitate on the cell boundaries near the fracture surface of fatigued specimen with $R = -1$ ([Fig. 5a](#)) is shown to be larger than that of $R = 0.5$ ([Fig. 4b](#)). Based on the analysis of the TEM dark field images, we further estimated the diameter of the Si precipitates and the results are shown in [Fig. 10](#). Despite the limitations of TEM for statistical analysis, the coarsening of Si precipitates is identifiable after VHCF with $R = -1$.

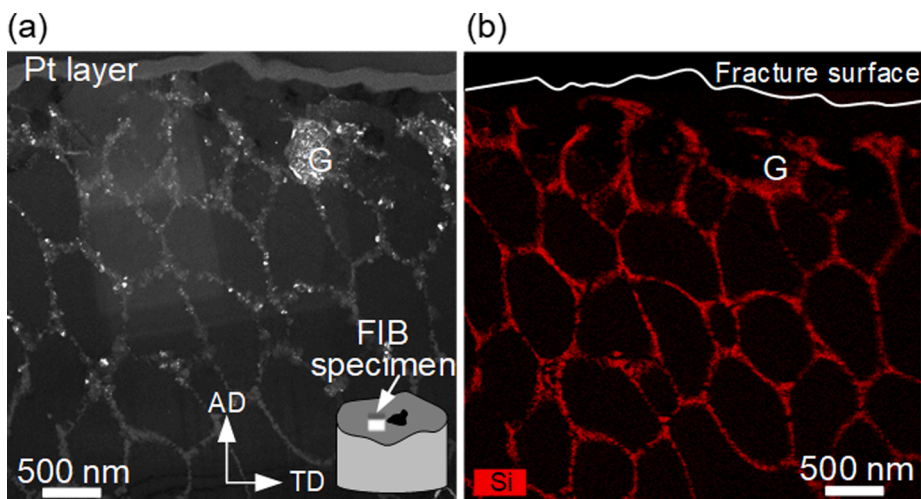
Fig. 5. (a) Dark-field TEM image and (b) Si elemental distribution map of the VHCF specimen with $R = -1$.

For the VHCF specimen under $R = -1$, a first look at the TEM microstructural results (Fig. 5a) reveals similar microstructures to the as-built condition (Fig. 2b), i.e. the fatigued specimen is still characterized by the cellular structures with the precipitates randomly distributed along the cellular network boundaries. Fig. 5b further presents the Si elemental distribution in the same observation region of Fig. 5a. High-resolution (HR)-TEM analyses were performed around the “G” location marked in Fig. 5a and b. The two observed positions are HR1 within the cell structure and HR2 on the cellular network boundary, as indicated in Fig. 6a. The observation positions of HR1 and HR2 regions are approximately 0.5 and 0.7 μm away from the fracture surface, respectively. HRTEM image of HR1 is displayed in Fig. 6b. A number of stacking faults (SFs) were observed in the HRTEM image of Al matrix (Fig. 6), as marked by arrows. Fig. 6c further shows the Inverse Fast Fourier Transformation (IFFT) image and Fast Fourier Transformation (FFT) image corresponding to the dashed area in Fig. 6b. It indicates that these are SFs parallel to one of the (1 1 1) planes corroborated by streaking parallel to $\langle 111 \rangle$ in the FFT of the corresponding image (the inset of Fig. 6c). The Al phase on the cellular network boundary was also noticed to contain a number of SFs as shown in the HRTEM image in Fig. 6d. The formation of SFs has also been observed in the Al-Mg-Si alloy subjected to the equal-channel angular pressing [30]. These SFs are possibly formed among partial dislocations in the Al alloys due to the severe plastic deformation.

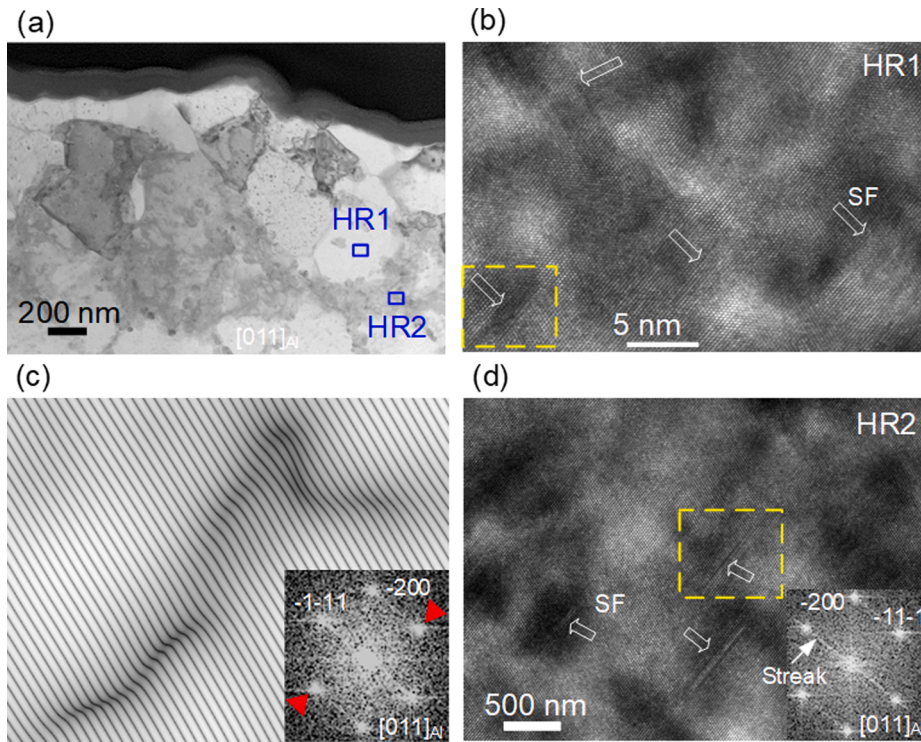
Fig. 6. (a) TEM image showing two HRTEM observation positions of HR1 within the cell structure and HR2 on the cellular network boundary, (d) HRTEM image for HR1, (e) Inverse Fast Fourier Transformation image together with the Fast Fourier Transformation image (inset) corresponding to the dash box area in d, (f) HRTEM image for HR2 with the Fast Fourier Transformation image corresponding to the dashed area.

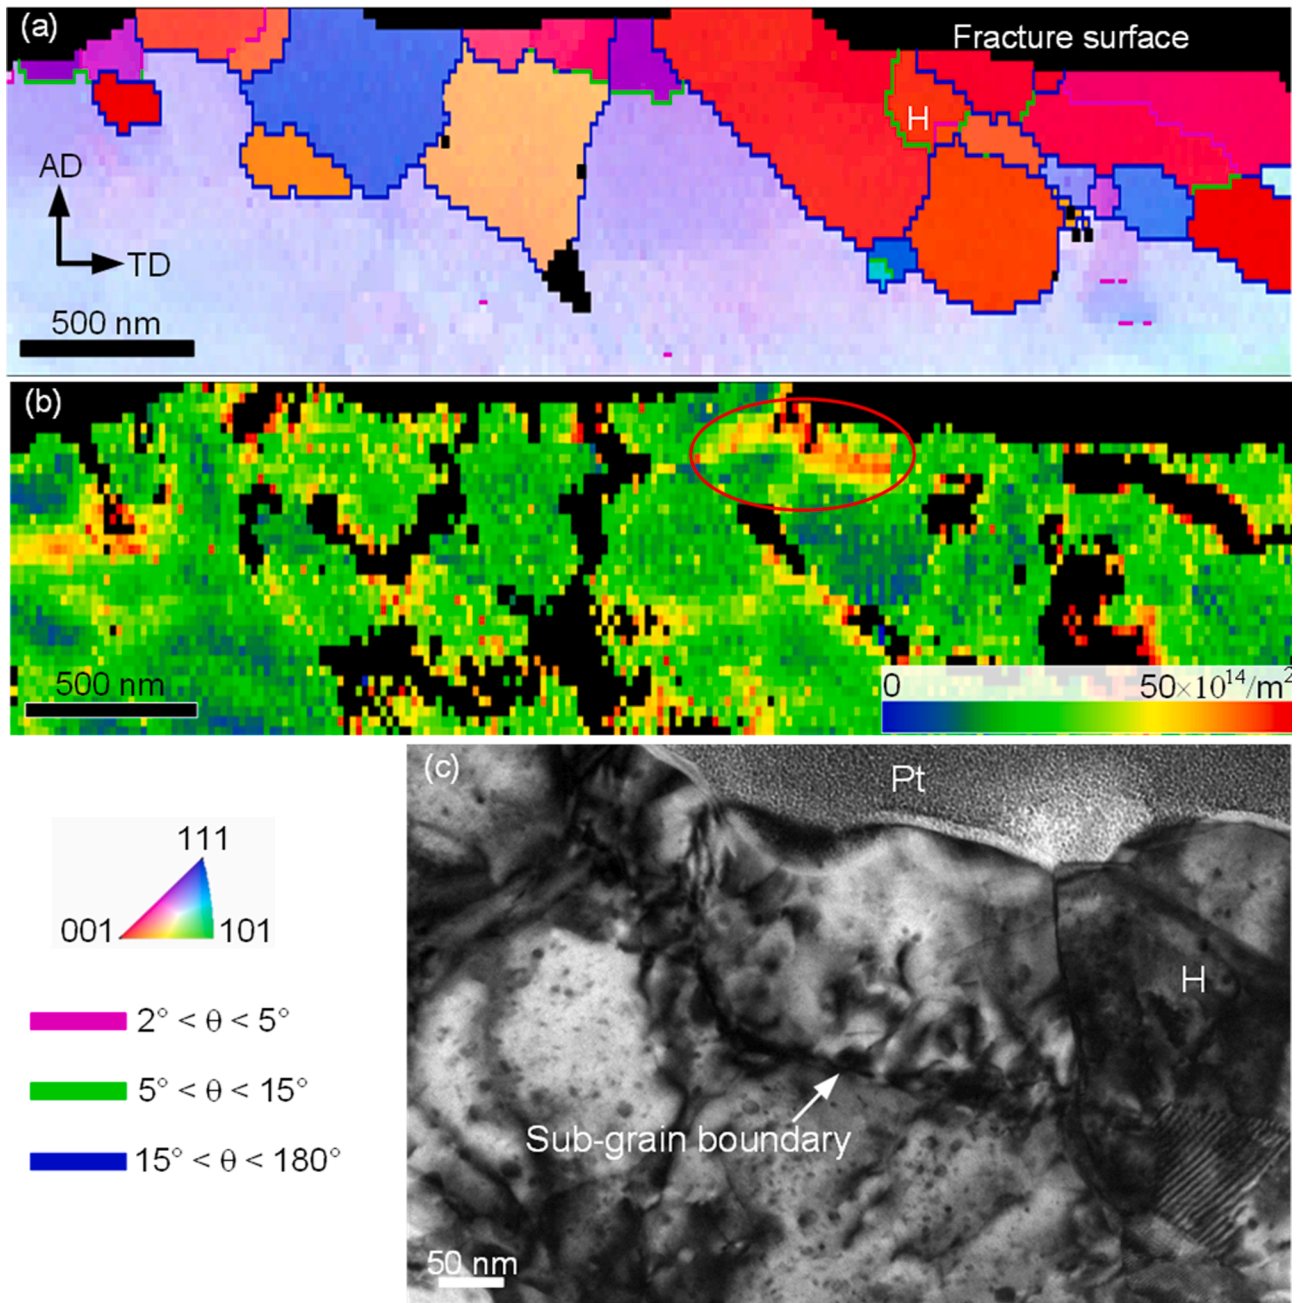
Fig. 7. (a) TKD-based orientation map showing the microstructure near fracture surface of VHCF specimen with $R = -1$, (b) GND distribution corresponding to (a), (c) dislocation configurations near the H area in (a).

Fig. 7a shows the TKD-based orientation map of the fatigued specimen near the fracture surface. A layer of fine Al grains with sizes varying from tens to hundreds nm underneath the fracture surface was observed, indicating that the refinement of matrix grains occurs during VHCF. In addition, the low-angle grain boundaries identified with misorientation between 2° and 15° were observed, which are presumably due to the accumulation of dislocations during VHCF. The corresponding GNDs density distribution of Fig. 7a is shown in Fig. 7b. Fig. 7c presents the dislocation configurations by TEM near the fracture surface (as marked by the letter H in Fig. 7a), and the sub-grain boundaries were observed. Compared with Fig. 7b and c, it is found that the dislocation density in the grains near the crack surface is locally concentrated to form sub-grain boundaries, as shown by the red line in the Fig. 7b. This implies that the local dislocation accumulation in the grains near the crack surfaces promotes the evolution of sub-grain boundaries to low-angle boundaries and high-angle boundaries.

It is believed that the grain refinement in VHCF is associated with the high-angle-boundary formation process. The models interpreting the formation mechanism of the fine-grained layer at the fracture surface of VHCF have been proposed [4,32–34], among which the numerous cyclic pressing (NCP) model [4] is generally accepted for providing a rationale for the formation of the fine-grained layer and its dependence on the applied stress ratio or compression stress. According to the NCP model, repeated contact stress between the crack surfaces and a sufficient number of tension-compression loading cycles experienced during VHCF are responsible for the grain refinement. The resultant local severe plastic deformation will result in the accumulation of a large number of dislocations, promoting the development of high-angle boundaries and the formation of fine-grained layer, as observed in [Fig. 7](#). However, for R

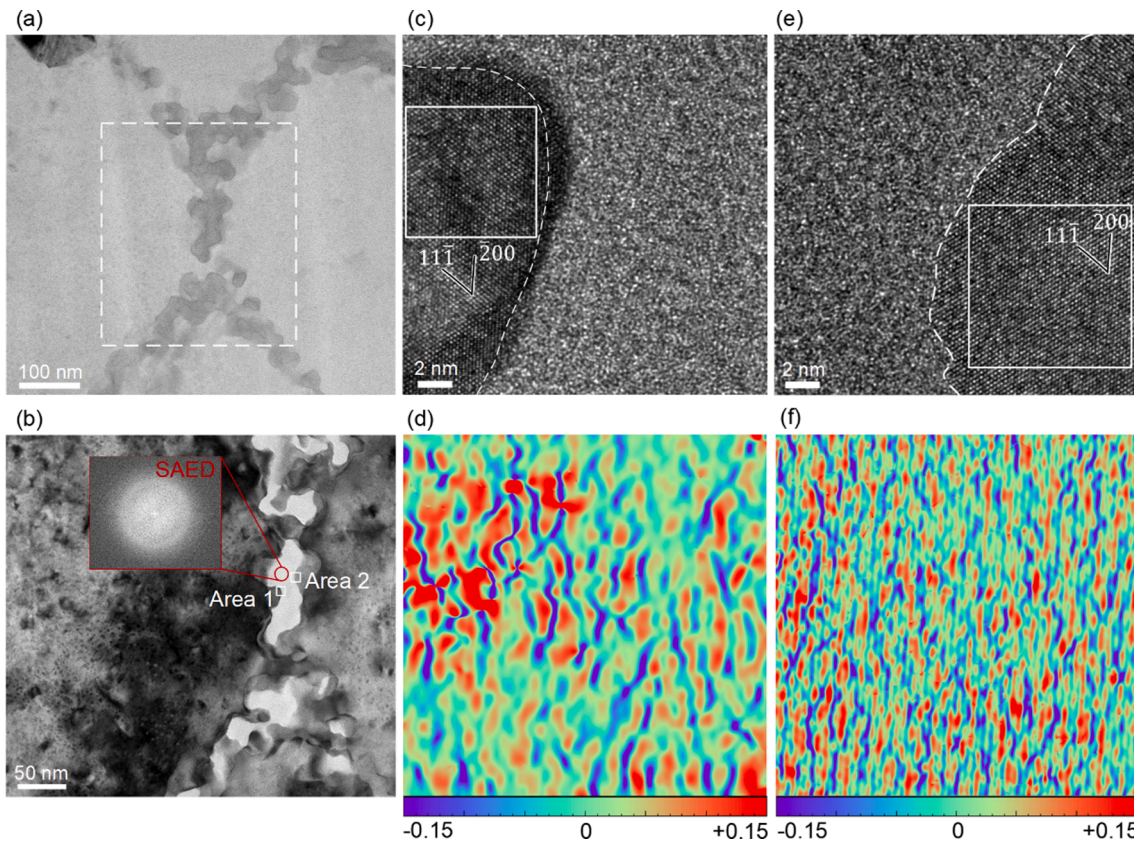
Fig. 8. (a) Si precipitates at the cellular grain boundaries at a distance of $\sim 2.8 \mu\text{m}$ from the fracture surface for fatigued specimen with $R = -1$. (b) A closed-view of the dashed box area in (a). HRTEM images of Area 1 and (f) Area 2 indicated in (b). GPA strain map imaged by [200] of the white-box regions in (d) Area 1 and (f) Area 2.

Fig. 8 shows a further close inspection of the Si-precipitation behavior after VHCF. The morphologies of Si particles at a distance of $\sim 2.8 \mu\text{m}$ from the fracture surface (Fig. 5a) are similar to those of the as-built material (Fig. 2b), i.e. the cellular boundaries compose of close-packed Si precipitates. Fig. 8b shows the TEM observation at a higher magnification corresponding to the dashed box area in Fig. 8a, as well as

the selected area electron diffraction (SAED) pattern of the Si particles. The SAED data shows diffuse halo rings, suggesting the amorphous nature of the precipitates. The amorphous Si-precipitates was frequently observed (see the [Supplementary Fig. S5](#)). [Fig. 8c](#) and [e](#) further present the HRTEM images of the Areas 1 and 2 in [Fig. 8b](#), respectively. The white dashed lines marked the boundaries of crystalline Si and amorphous regions. A HRTEM analysis was further conducted to reveal the distribution of defects induced by fatigue deformation. Lattice defects generally produce the lattice strain, which can be evaluated through the geometric phase analysis (GPA) of HRTEM images [31]. [Fig. 8d](#) and [f](#) show the GPA strain maps of the white-box regions in [Fig. 8c](#) and [e](#), respectively. The color scale in the bottom of the [Fig. 8d](#) and [f](#) shows the magnitude of the lattice strain, in which the positive values indicate the tensile strain whereas the negative values mean the compression strain. As confirmed by [Fig. 8d](#) and [f](#), a significant strain gradient and large local strain field occurs at the fatigue fracture surface under $R = -1$.

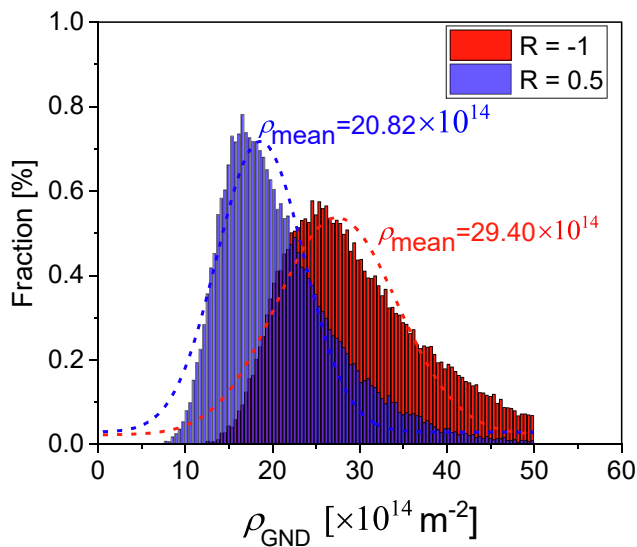
Fig. 9. Distribution of discrete GND density determined from TKD-based measurements at the fracture surface of fatigued specimens.

$= 0.5$, there is no pressing of crack surfaces due to its positive stress ratio, resulting in insufficient local plastic accumulation to form large angle grain boundaries. According to the TKD analysis results of $R = -1$ and 0.5 , the GND density is statistically analyzed and shown in [Fig. 9](#). The mean GND densities of fatigued specimen with $R = -1$ is estimated to be $\rho_{\text{mean}} = \sim 29.40 \times 10^{14} \text{ m}^{-2}$, while that for the specimen of $R = 0.5$ is a bit lower ($\rho_{\text{mean}} = \sim 20.82 \times 10^{14} \text{ m}^{-2}$). In particular, the local accumulation of dislocations at fracture is more significant ([Fig. 7b](#)) due to the repeated cycling process of crack opening, closure and contact under $R = -1$. The results indicate that the strain gradient is more severe in the fatigued specimen with $R = -1$ than that of $R = 0.5$, leading to a higher density of GNDs as well as the formation of fine-grained layer.

f), as determined in Fig. 9. In addition, the tensile stress under $R = 0.5$ promoted crack growth. This is the main reason for the decreased fatigue life and no grain refinement on fracture surfaces.

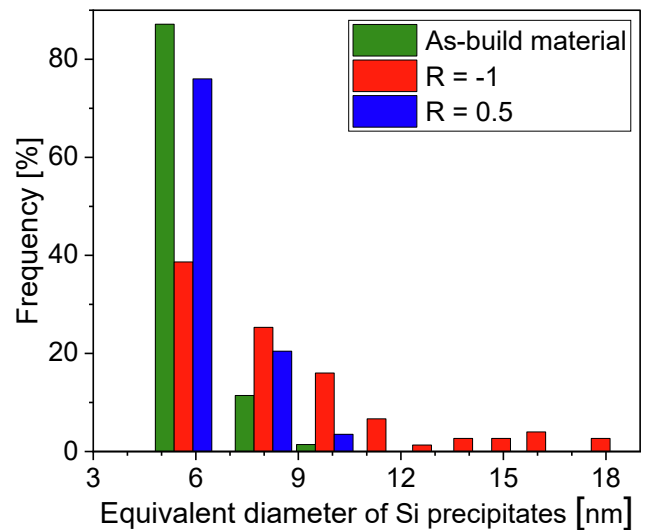
Fig. 10. Measurement of the equivalent diameter of Si precipitates in the as-built microstructure and at the fatigue-induced fracture surfaces under $R = -1$ and 0.5.

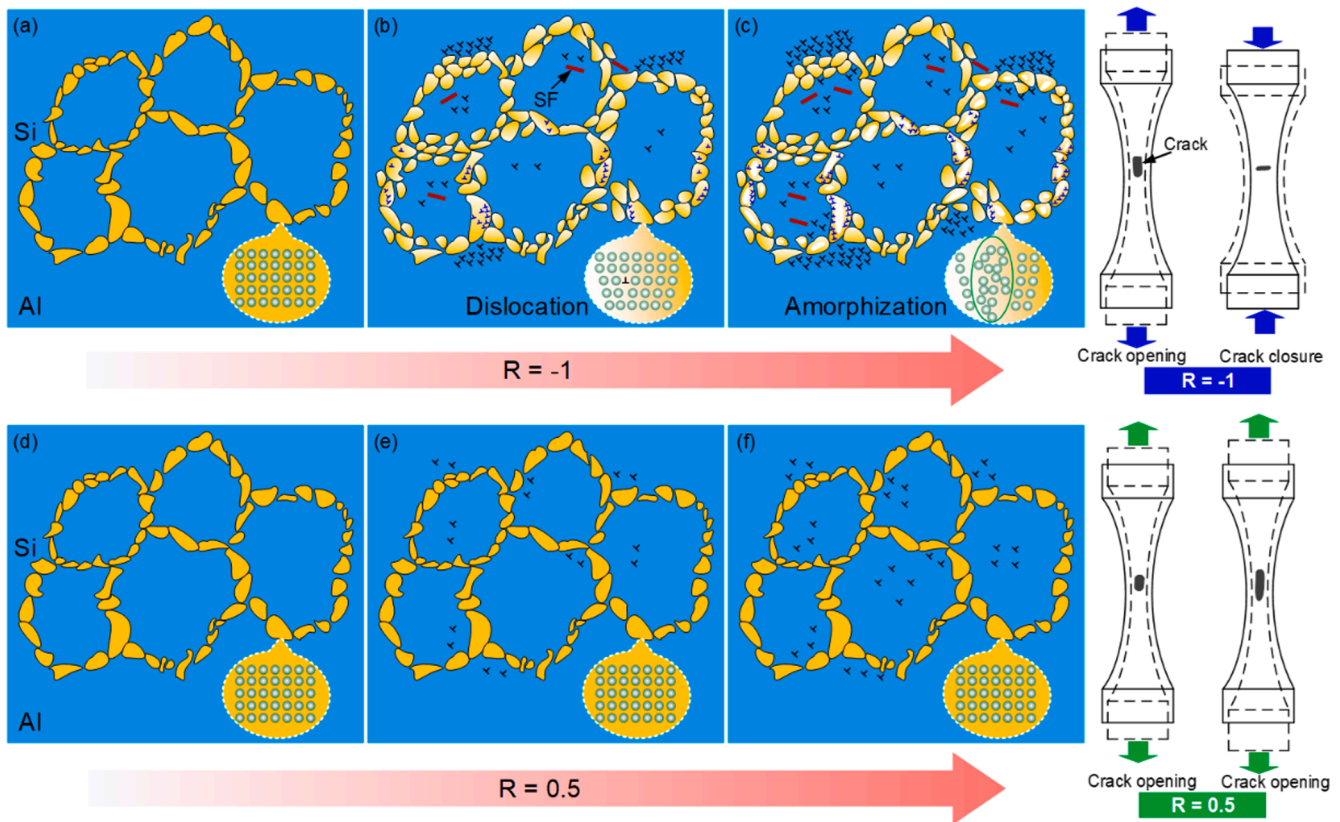
Fig. 11. A schematic showing the microstructural evolution during VHCF under $R = -1$ and 0.5: (a) and (e) initial Si precipitates on the cellular network boundaries, (b) activation of dislocations and formation of stacking fault for Al phase, and plastic deformation and growth of Si particles, (c) amorphization of Si precipitates and formation of sub-grain boundaries under $R = -1$. (e) Activation of dislocations and (f) dislocations pile-up for Al phase under $R = 0.5$.

In the present study, it is demonstrated that VHCF with $R = -1$ exhibits a microstructural characteristic distinct from that of $R = 0.5$. In the former case, the applied negative stress ratio in the fatigue test greatly affects the microstructural evolution at the fracture surface. Fig. 11 schematically shows the microstructural evolution of VHCF with $R = -1$ and 0.5. In the as-build material, closed-packed Si precipitates are distributed along the cellular network boundaries, as shown in Fig. 11a and d. Once a crack is initiated, the crack surfaces will be cyclically pressured under tension-compression loading and thus induce local severe plastic deformation. Therefore, dislocation slip in Al grains and Si precipitates was activated, resulting in the development of lattice defects and misorientation in Si precipitates (Fig. 11b). With the accumulation of local strain, the dislocation in Al phase caused pile-ups at the cell boundaries. When the intensified stress that originated from pile-up dislocations in the Al phase was excessive, SFs would form, as observed in HRTEM images in Fig. 6b and d. For the Si precipitates, closed-packed arrangement along the cellular network boundaries, dislocation movement was strongly hindered due to copious interfaces such as grain boundaries. Dislocations tended to be accumulated in a small deformation volume. When the defect density in the Si precipitates reaches a critical level, they generate islands of amorphous material, Fig. 11c. Under the cyclic loading of ultra-long cycles, the high-density dislocation introduced by cyclic pressing of crack surfaces developed into sub-grain boundaries (Fig. 11c) and eventually formed large-angle grain boundaries, and grain refinement near the crack surfaces occurred.

In contrast, for $R = 0.5$, the specimen is in pull-pull loading mode, that is, there is no cyclic pressing on the crack surface. The plastic deformation near the crack surface is significantly smaller than in the case of $R = -1$. Therefore, fewer dislocations are activated (Fig. 11e and
